Monitoring Cruise at the  
Cornfield Shoals Disposal Site  
August 1992

# Disposal Area Monitoring System DAMOS

Contribution 106  
January 1996

Report No.  
SAIC C112

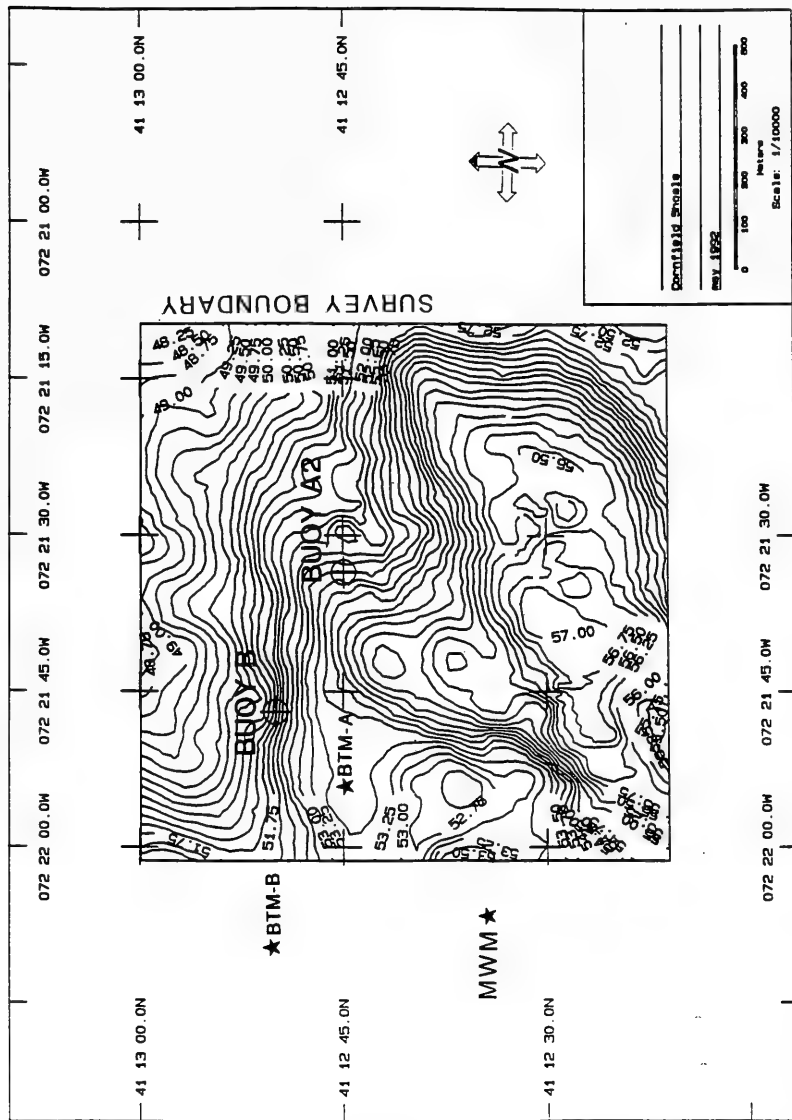
Figure 1-2. Location of disposal buoy and current meters at the Cornfield Shoals Disposal Site, 1991-1992

As part of a joint study between the University of Connecticut and the Newport, RI, office of Science Applications International Corporation (SAIC), a taut-wire moored buoy was deployed at two locations within CSDS in 1991. Between 12 September and 9 October 1991, 50,803 m<sup>3</sup> of sandy dredged material was released at buoy location A2 (Figure 1-2). Between November 13, 1991 and April 14, 1992, 105,479 m<sup>3</sup> of fine-grained dredged material from North Cove was released at buoy location B. Coincident with these disposal operations, a near-bottom current meter was deployed at BTM-A (near A2) on August 8, prior to disposal, and moved to BTM-B (near B) on October 21. A midwater current meter (MWM) was deployed southwest of BTM-A on August 1 (Figure 1-2). A series of studies at CSDS from July 1991 (predisposal) to May 1992 (postdisposal) documented the accumulation of dredged material at these buoy locations and provided circumstantial evidence for active bed transport in the area (Wiley 1994). The current meter data showed the east-west tidal component as the dominant current direction. Maximum velocities for the midwater meter were 120 cm·s<sup>-1</sup> on the spring tide and 60 cm·s<sup>-1</sup> on the neap. For the nearbottom meter, maximum velocities were 80 cm·s<sup>-1</sup> on the spring and 40 cm·s<sup>-1</sup> on the neap. All of these current velocities are sufficient to erode medium to fine sands (Bohlen et al. 1992)

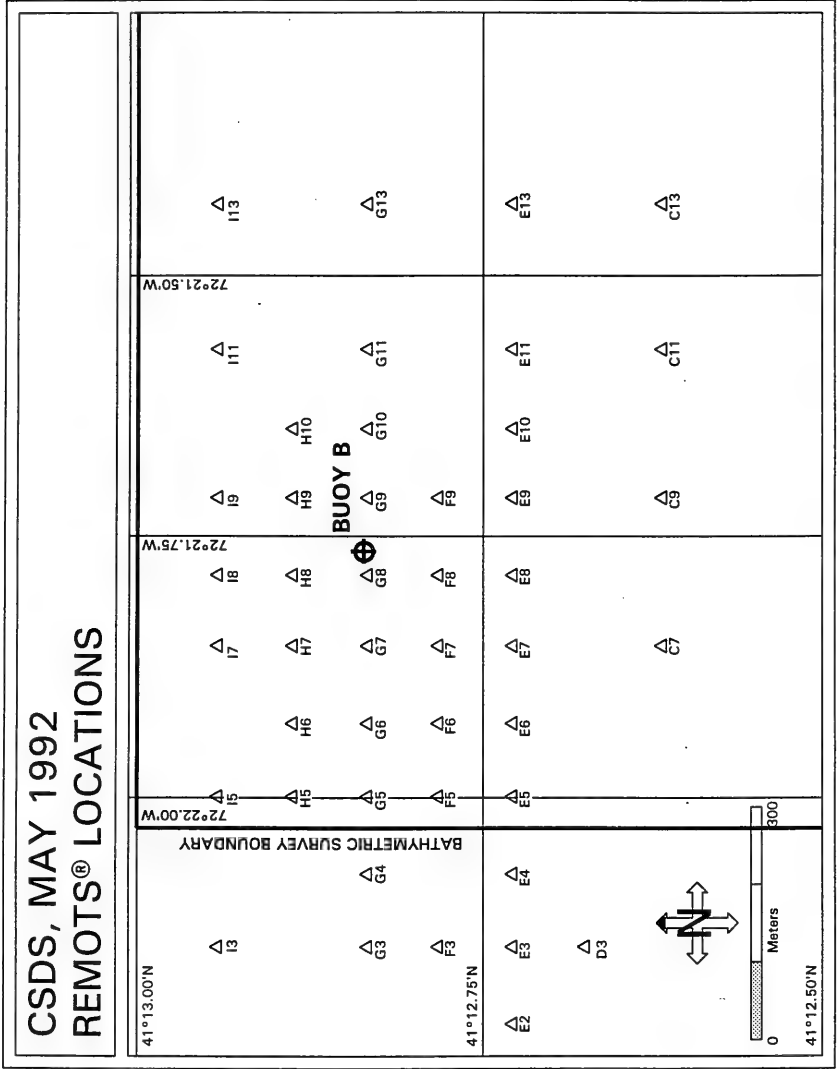
Figure 2-1. REMOTS® station locations at the Cornfield Shoals Disposal Site, May 1992

A REMOTS® survey was conducted at CSDS on August 6, 1992 to define the limits of dredged material distribution. In May 1992, a 45-station orthogonal REMOTS® grid had been surveyed to define the dredged material boundary (Figure 2-1). In August 1992,

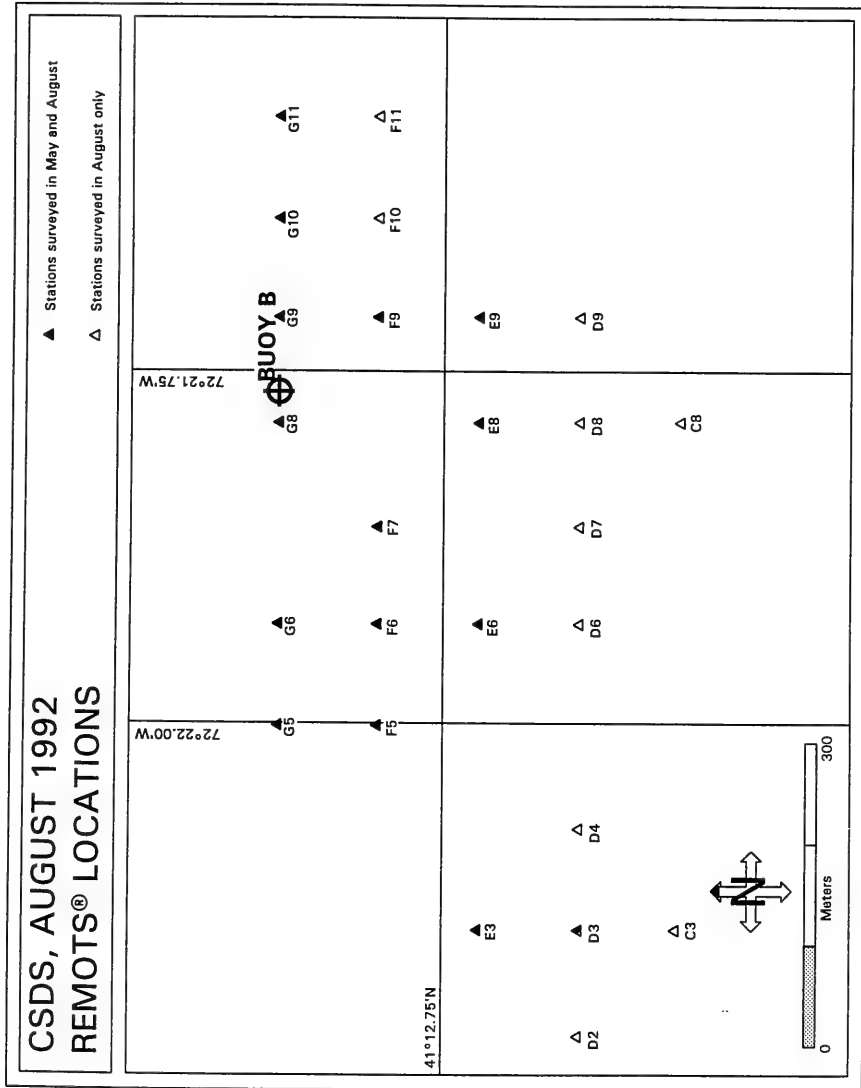
**Figure 2-2. REMOTS® station locations at the Cornfield Shoals Disposal Site, August 1992**

15 stations were resurveyed. Ten additional stations along the southern boundary of the dredged material deposit were surveyed at this time to map further the extent of the fine-grained dredged material documented in the May survey (Figure 2-2). Three replicates were taken at all stations. Analysis of the REMOTS<sup>®</sup> sediment-profile photographs was limited to grain size measurement, average penetration, and documentation of the presence of dredged material.

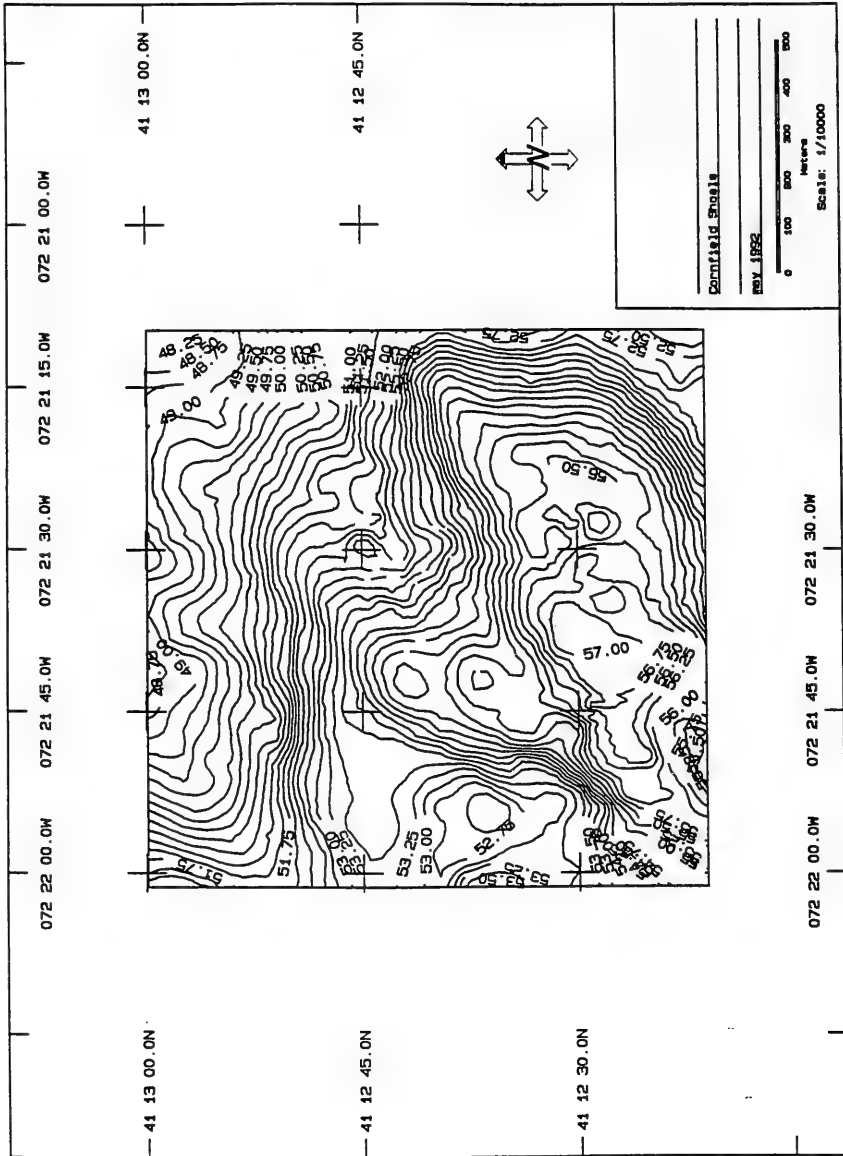
Figure 3-1. Bathymetric contour plot at the Cornfield Shoals Disposal Site, May 1992 (depth in meters)

The bathymetry at CSDS changed very little between May 1992 (Figure 3-1) and August 1992 (Figure 3-2). At approximately 72°21.75' W and 41°12.85' N, the mound formed by the disposal of fine-grained sediment from North Cove caused the contour lines to bend to the south in both surveys. South of 41°12.50' N, the contours in the August survey were slightly deeper and more convoluted than in May. This is the area where sand waves were recorded in the fathometer trace in May (Wiley 1994). Comparing depths in the two bathymetric surveys showed very little loss from May to August (Figure 3-3). Five areas of -20 cm depth difference exist, each a maximum of 75 m in diameter. Up to 40 cm of material had accumulated at 16 locations in the southern portion of the survey area from May to August (Figure 3-4). Each of these areas was less than 100 m in diameter.

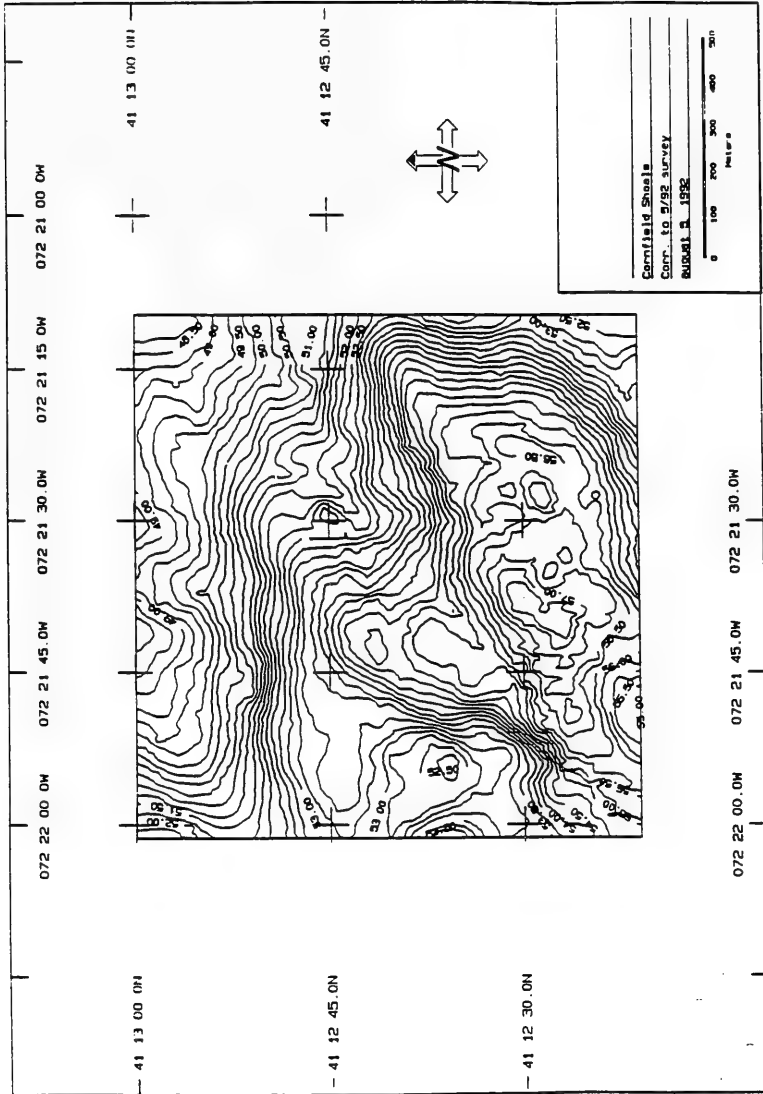
Figure 3-2. Bathymetric contour plot at the Cornfield Shoals Disposal Site, August 1992 (depth in meters)

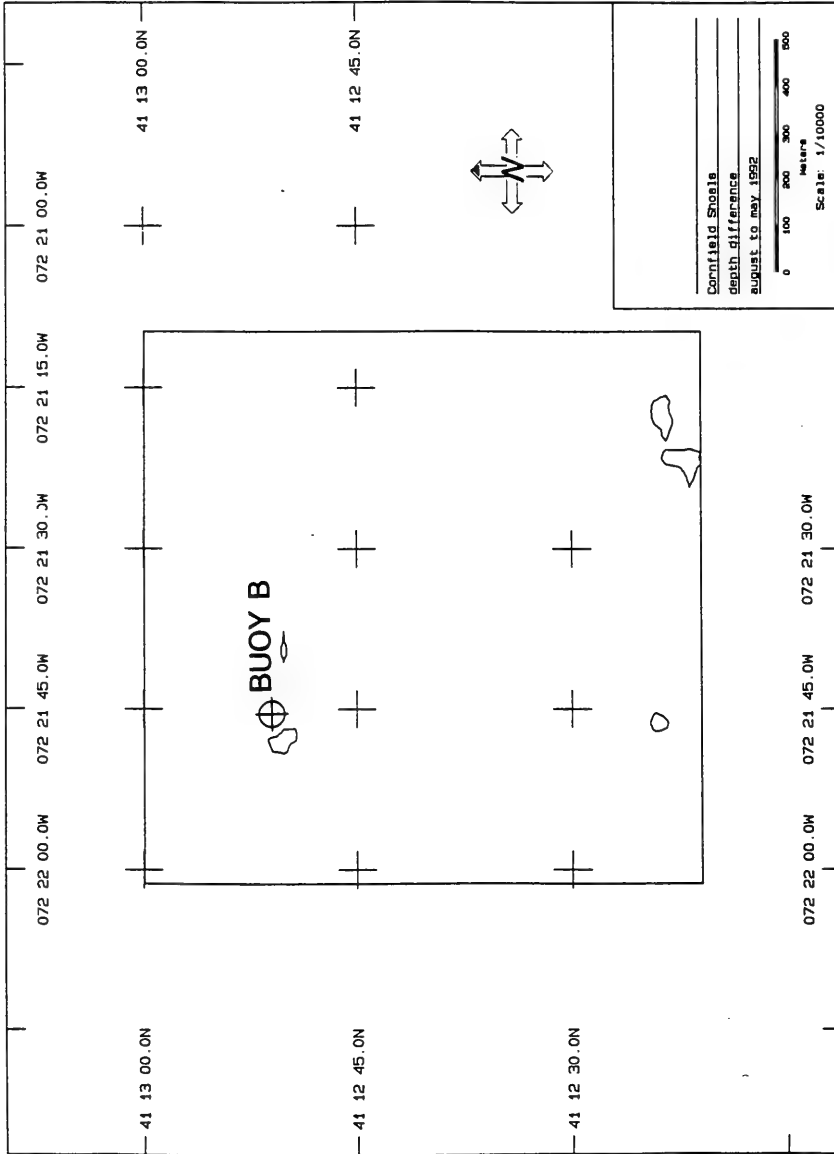
Figure 3-3. Negative depth difference contour plot between May 1992 and August 1992 (contours at 0.2 m)

At the North Cove buoy location, up to 50 cm of dredged material had accumulated between December 1991 and May 1992 (Wiley 1994). The two areas of 20 cm loss in August were to the east and west of this area of accumulation. Based on the bathymetric measurements, there was no change in the water depth at the center of the disposal mound between May and August, again supporting the relative stability of the fine-grained deposit.

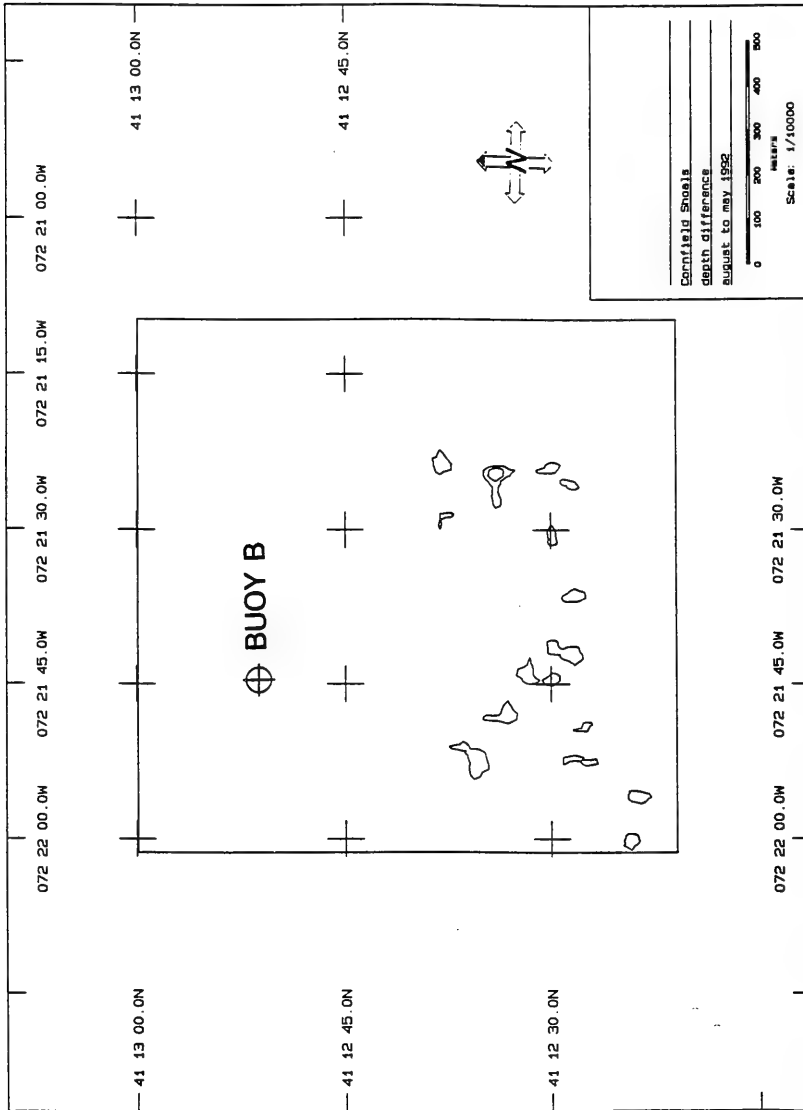
**Figure 3-4.** Positive depth difference contour plot between May 1992 and August 1992 (contours at 0.2 and 0.4 m)

Comparing the May to August bathymetric surveys showed a clustering of positive depth differences in the southern portion of the survey area. This coincides with the known location of a sand wave field. Migration of sand waves (part of the east-west transport supported by previous studies [Wiley 1994]) could have caused the accumulations noted between May and August 1992. The north-south alignment of the areas of accumulation are also parallel to the wave crests.

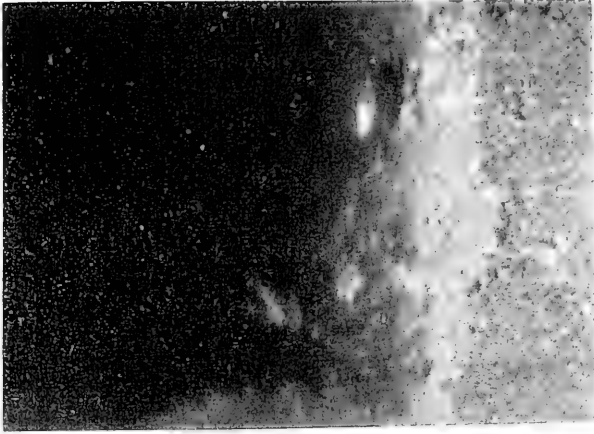
**Figure 3-6.** Station E3 showing sand/mud in May 1992 (A) and sand in August 1992 (B)

Of the 25 REMOTS® stations surveyed at CSDS in August 1992, two were fine-grained dredged material, and four were sand over mud. The remaining stations were sand (Figure 3-5). The two stations with fine-grained dredged material (G8 and G9) were located closest to the specified disposal point. Of the REMOTS® stations that were surveyed both in May and August 1992, E3, F6, F7, G5, G10, D3, F8, and E9 were sand over mud in May, but only sand was visible in August (Figure 3-6). Station F9 was ambient sandy sediment in May, but in August it was sand over dredged material (Figures 3-7 and 3-8). Stations G6, G8, and G9 remained unchanged. Sand is very difficult for the REMOTS® camera to penetrate; as a result, REMOTS® photographs taken at a sandy station usually have very low penetration and often do not show the subbottom structure. Ten new stations were surveyed in August to determine if there was any other fine-grained material at the site that had not been detected in May. Eight of these stations detected only sand, but D6 and D7 showed sand over fine-grained dredged material.

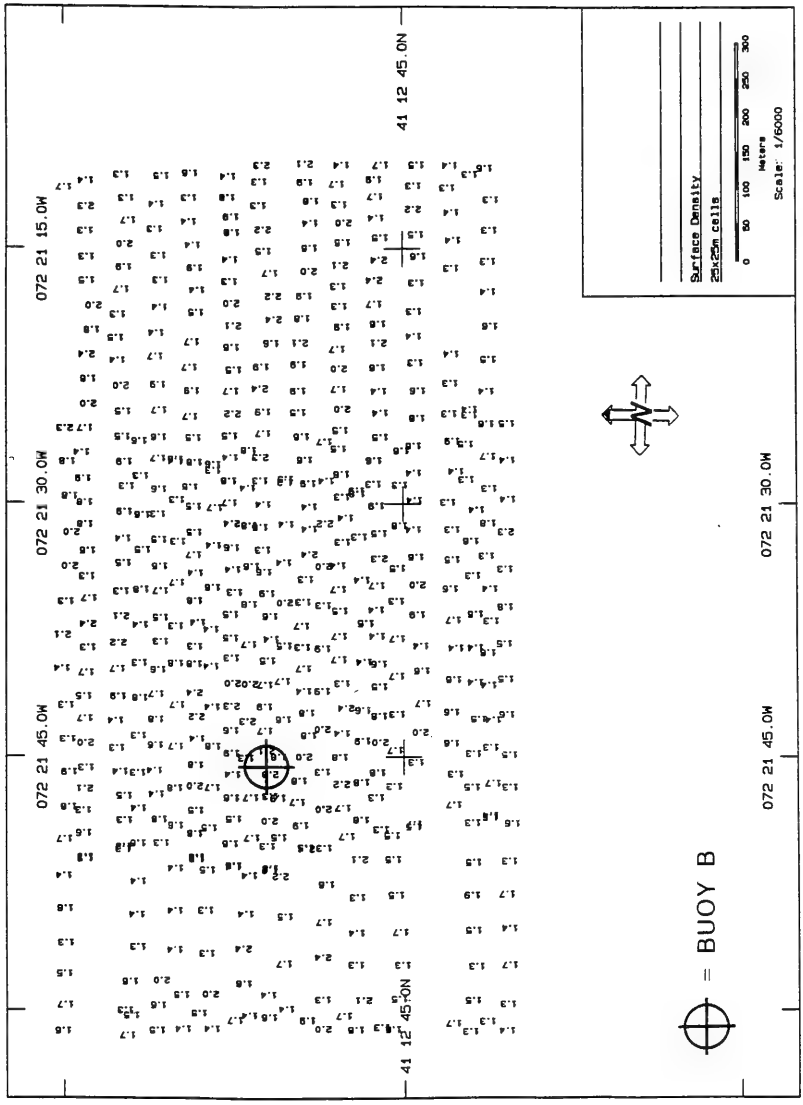
Figure 3-9. Smooth sheet of surface sediment density ( $g\text{-}cc^{-1}$ ) at the Cornfield Shoals Disposal Site, August 1992

Surface density data ranged from  $1.3 \text{ g}\cdot\text{cc}^{-1}$  to  $2.3 \text{ g}\cdot\text{cc}^{-1}$ . The surface sediment density data show high variability between data points (Figure 3-9). At REMOTS® stations G8 and G9, where the median grain size mode was greater than 4 phi (silt/clay), the density values range from  $1.5$  to  $1.8 \text{ g}\cdot\text{cc}^{-1}$ . The remaining REMOTS® stations surveyed in August all had grain sizes of one to two phi (medium to fine sand) which should correspond to densities of more than  $1.9 \text{ g}\cdot\text{cc}^{-1}$ . The density data show values of  $1.3 \text{ g}\cdot\text{cc}^{-1}$  and greater at all the REMOTS® locations. The contour plot of the density data (Figure 3-10) shows areas of relatively uniform density between  $1.3$  and  $1.6 \text{ g}\cdot\text{cc}^{-1}$ . Values greater than  $1.6 \text{ g}\cdot\text{cc}^{-1}$  (Figure 3-11) are concentrated north of  $41^{\circ}12.75' \text{ N}$ .

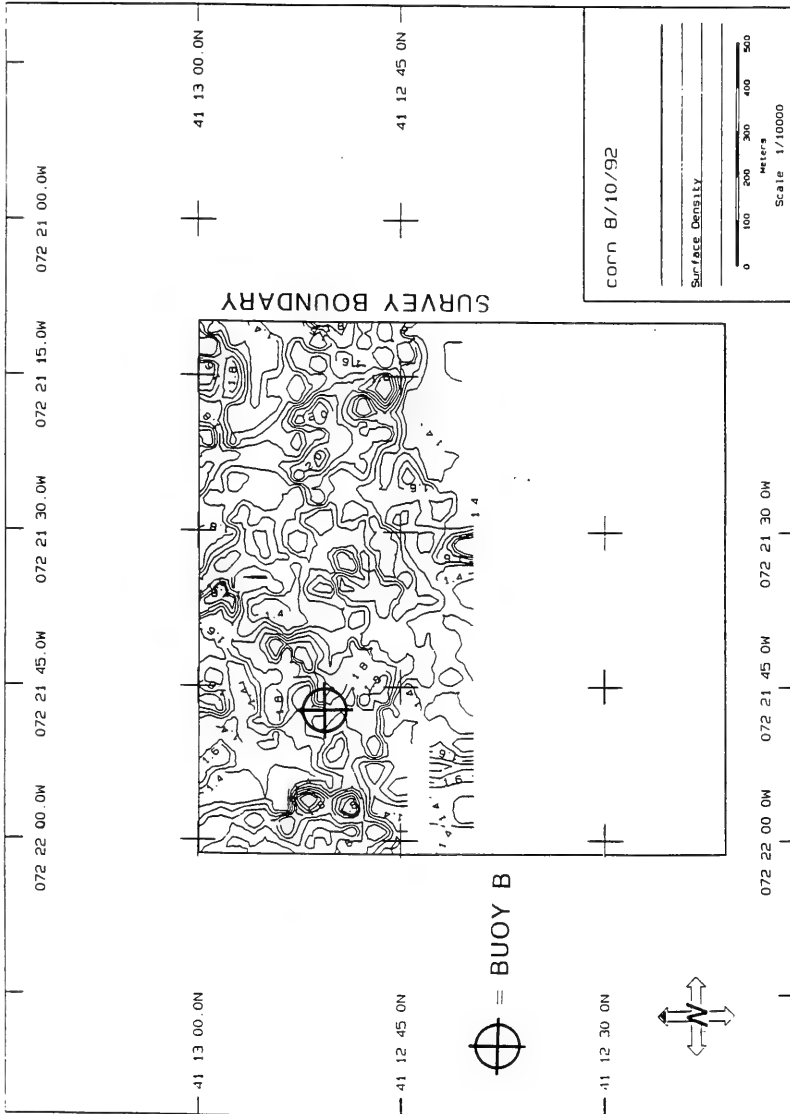
Figure 3-10. Contour plot of surface sediment density (g-cc<sup>-1</sup>) at the Cornfield Shoals Disposal Site, August 1992

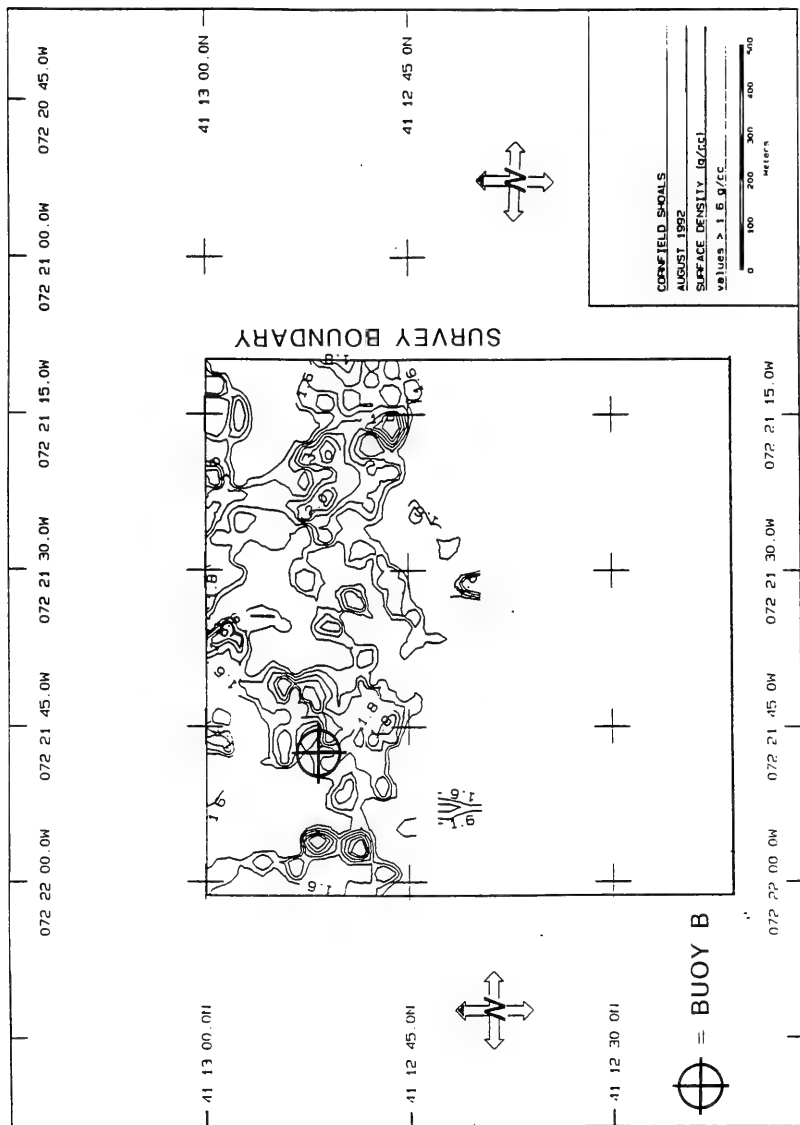
Figure 3-11. Surface sediment density values  $> 1.6 \text{ g}\cdot\text{cc}^{-1}$

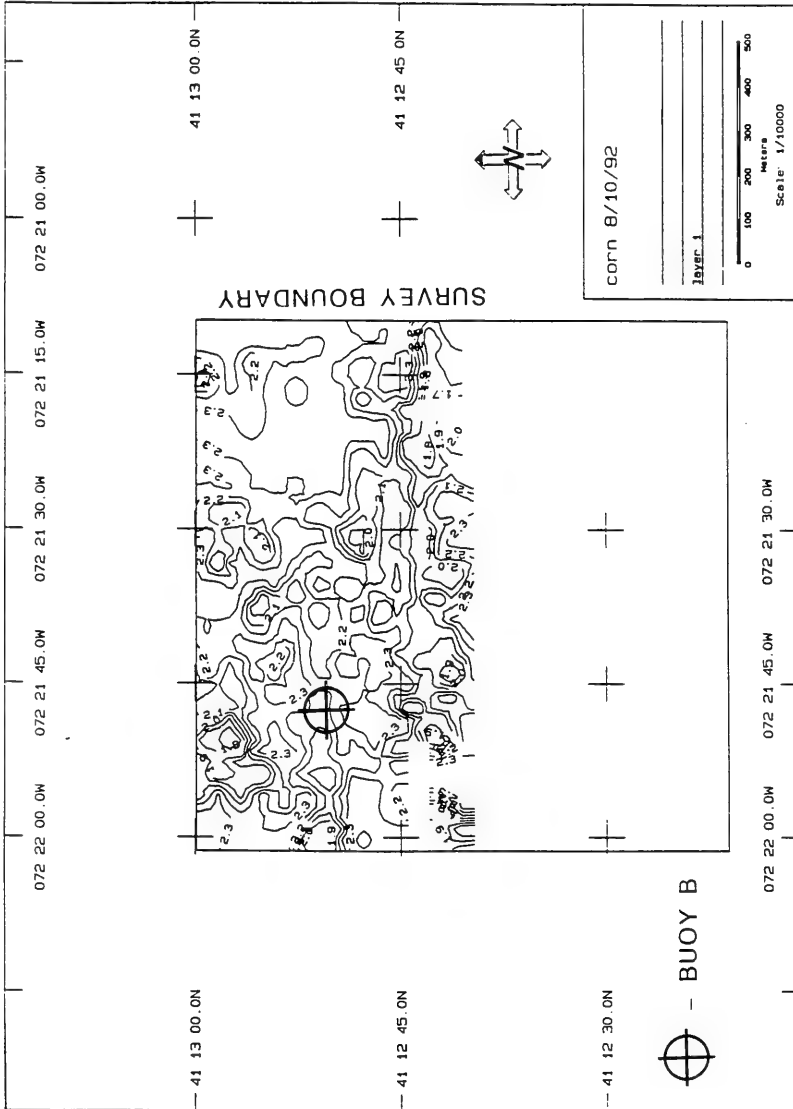
**Figure 3-12.** Sediment density ( $\text{g}\cdot\text{cc}^{-1}$ ) at the Cornfield Shoals Disposal Site, approximately 15 cm below the sediment surface

Subsurface sediment density at CSDS was collected at 15 cm intervals below the surface. Data was collected for multiple intervals although attenuation and data degradation prevented any realistic analysis on all but the initial layer. The contour plot of the density values of the first layer (15 cm below the sediment water interface) shows an increase in density at all points of the survey (Figure 3-12).
